Customer Alert

Revised shipping details for returning SG1024 Printheads

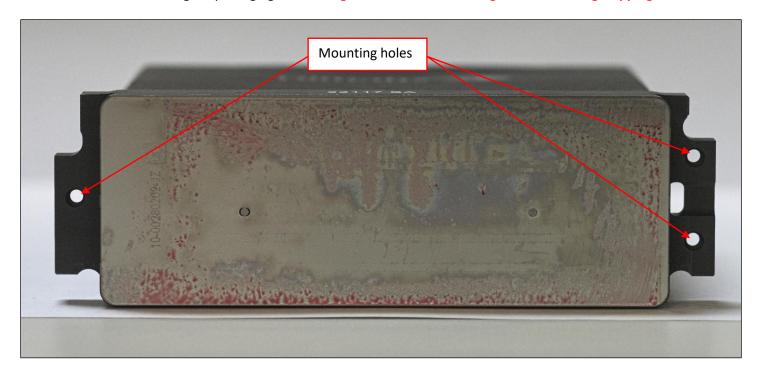
Figure 1

Bottom view of a new Printhead

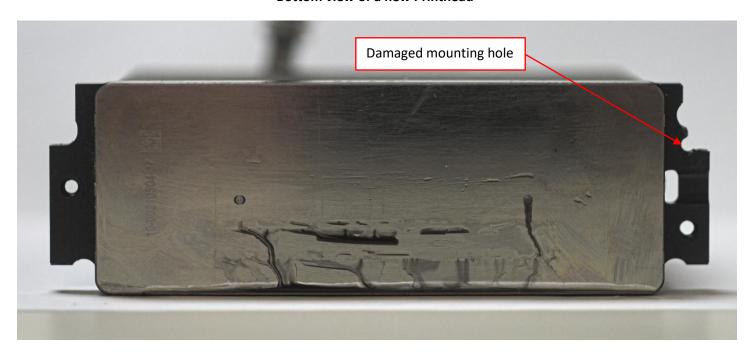
Shipping Package Peculiarity

The package bottom in which the Printhead is shipped has clearance cutouts for the mounting surface that are not symmetrical. The cutout is larger on the right-hand side. This peculiarity in the package can result in Printhead damage as seen in Figure 2 above. The cause of this damage is due to leaving the mounting screws in the Printhead when placing it in the package bottom. If the side of the Printhead with the 2 mounting screws in placed in the package with the 2 screws on the left-hand side, it can result in fracturing the mounting surface in an irreparable way. The wrong orientation is shown below.

The simplest solution to avoid this damage is to remove the mounting screws and springs before placing the Printhead in the original packaging. The unsymmetrical clearances in the packaging will have no effect on the Printhead if the mounting screws and springs are not left in the Printhead. Whenever shipping a Printhead for any reason, remove the mounting screws before placing it in the package.

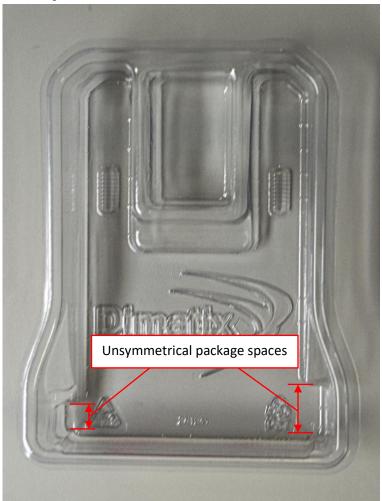
Figure 3

Bottom of Printhead shipping package

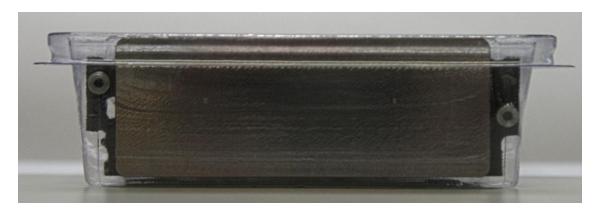
Figure 4 shows the wrong orientation of the Printhead in the package. The lack of clearance on the left-hand side of the packaging **combined with leaving the mounting screws in the Printhead** can cause the mounting screw to break out the mounting hole in the Printhead as shown below.

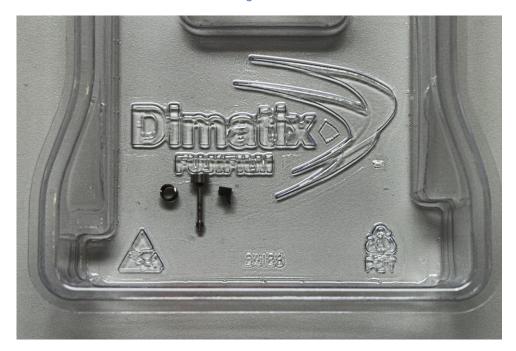
Figure 6

Loose mounting screw and spring with the broken piece of Printhead found when a Printhead was returned for service.
