Replacing Internal Ethernet Cable for DICEblade Control Board

For failing ethernet cable characterized by intermittent connection to blades. 07.13.2022 Version 1.0

Prototype & Production Systems, Inc. 4830 Azelia Avenue North, Suite 300 Brooklyn Center, MN 55429 (763) 557-9348

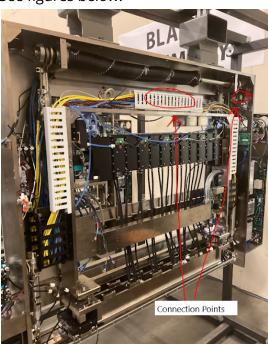
- Remove blade covers to complete this process.
- Turn off drive electronics power.
- Cap the heads. Check access to the DICEblade Control PCB located at the top of the blade, above the ink supplies. If access is difficult it may be necessary to lower the heads for easier access. If this is needed, it would be a good idea to turn off circulation as well as the weir vac. Wait for the ink to pool in the res before uncovering the heads.
- Locate the cable connections at the DICEblade Control PCB and the blade bulkhead. See figures below:

- Disconnect cable shown in the picture labeled "Main Tile" and remove from e-chain and blade wireways. This cable likely goes through the e-chain that you can see on the left in the picture above and then back through the wire channel located behind the spring assembly at the top of the blade. The cable should be 10 ft long. See below for potential routing path:

- Double check new cable is Cat6a STP (shielded twisted pair). Add the label "Main Tile" to the new cable.
- Route the new cable in the same path as the previous cable.
